LAWRENCE
LIVERMORE
NATIONAL
LABORATORY

LLNL-TR-648143

A Visual Description of the Concrete Exterior of the Cactus Crater Containment Structure

October 2013

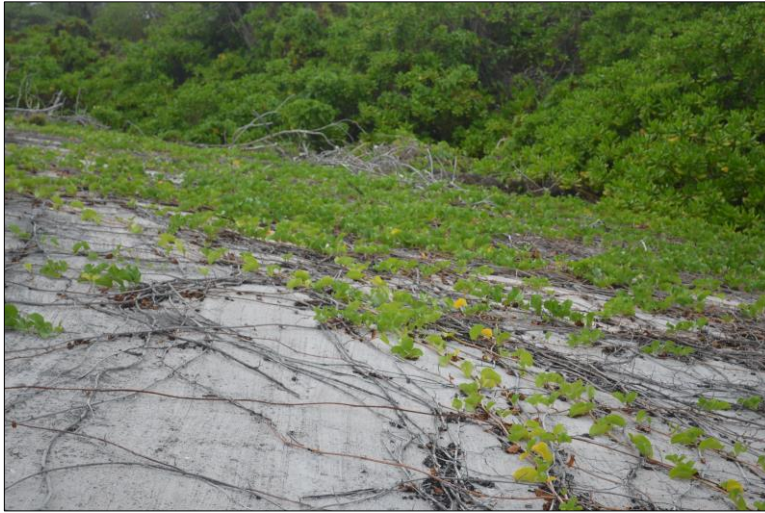
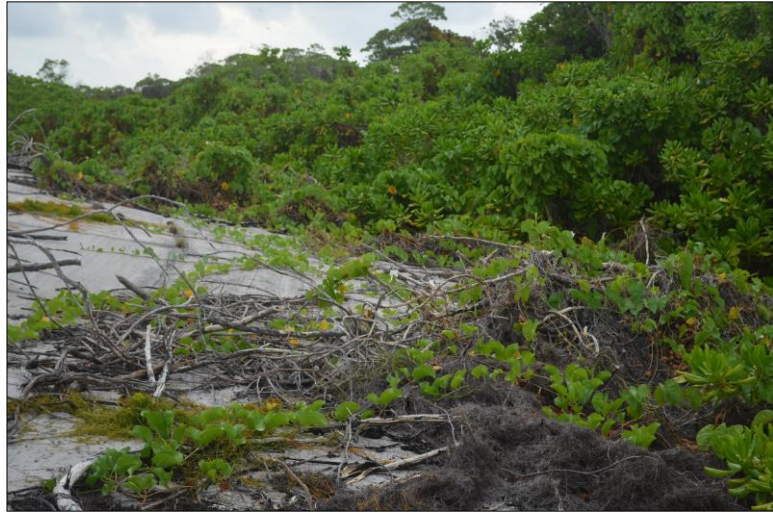
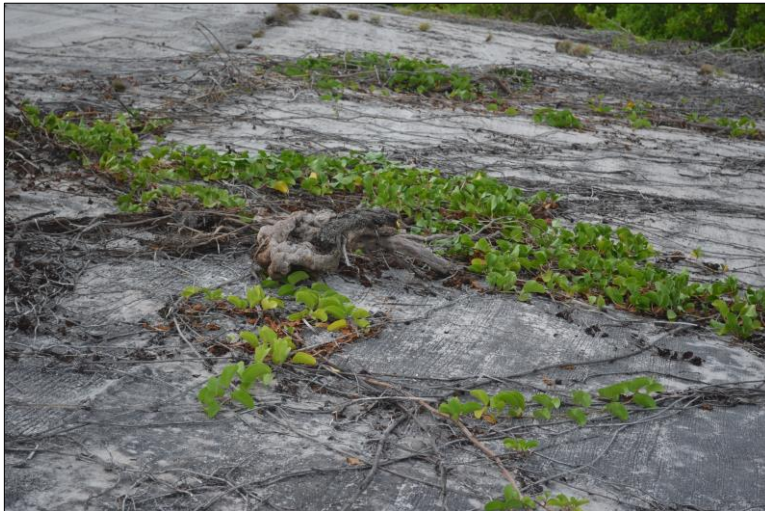
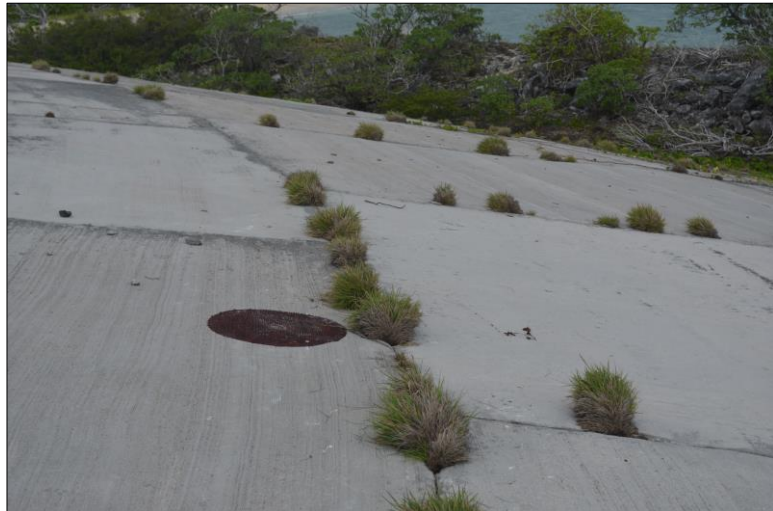
Fig 12. Vegetation growth over the face of *Runit Dome* (Initial conditions, Visual Survey, May 2013).

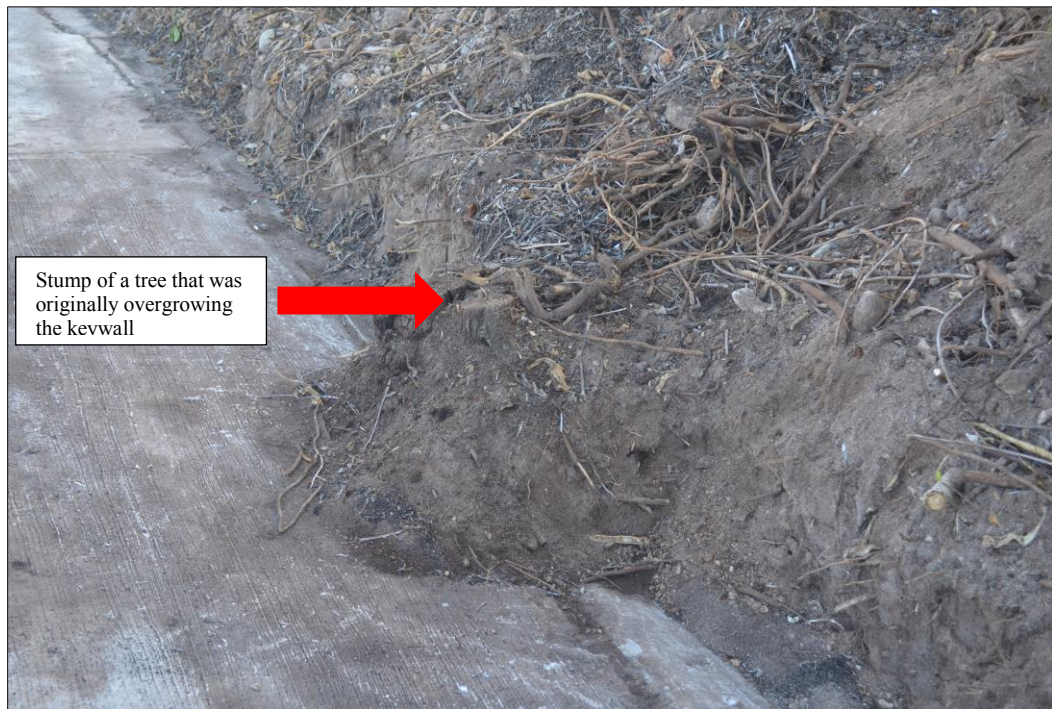
Fig 14. A photo of a tree stump located over the keywall (the stump was later removed) (Visual Survey, May 2013).

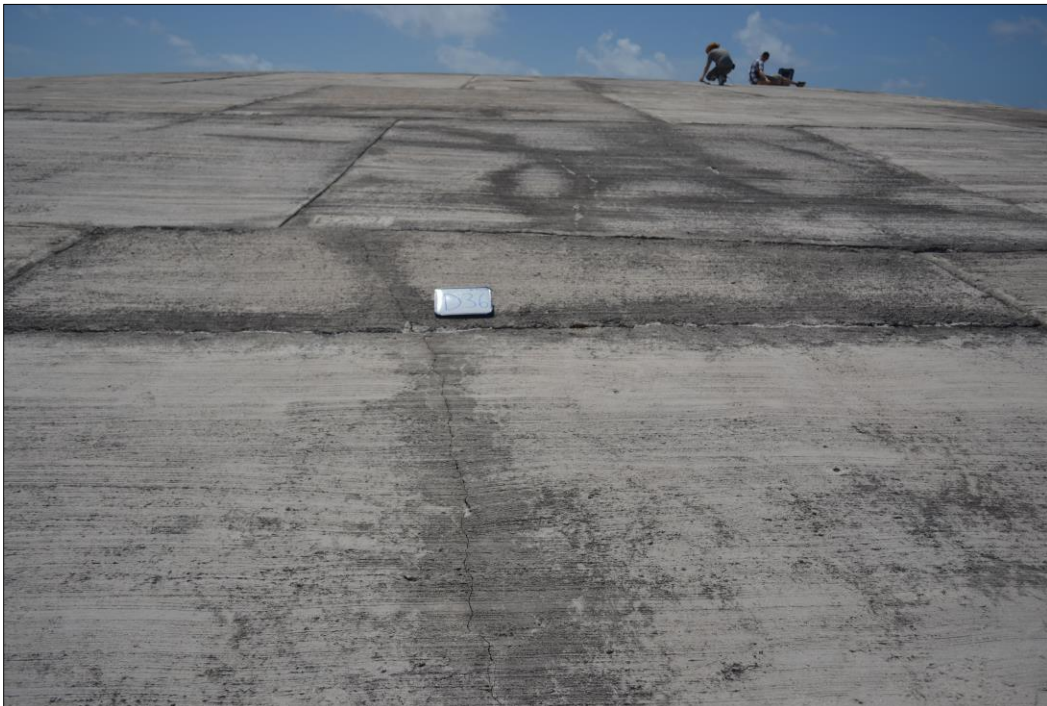
Similarly, streaks of discoloration along crack lines and seam edges may be caused by the action of rainwater penetrating down into the cracks and leaching out sea salts from below the surface of concrete. The salt then re-deposits by drying on the surface of the concrete to give each crack line a distinctive appearance. In order to determine the exact cause for the weathered appearance and discoloration of the concrete panels, petrographic and chemical analyses need to be performed on concrete cores collected from a series of light and dark colored patches of concrete from different panels around the dome (Concrete Science, Inc., 2013).

Fig. 17. Concrete panels showing streaks of discoloration running along crack lines.

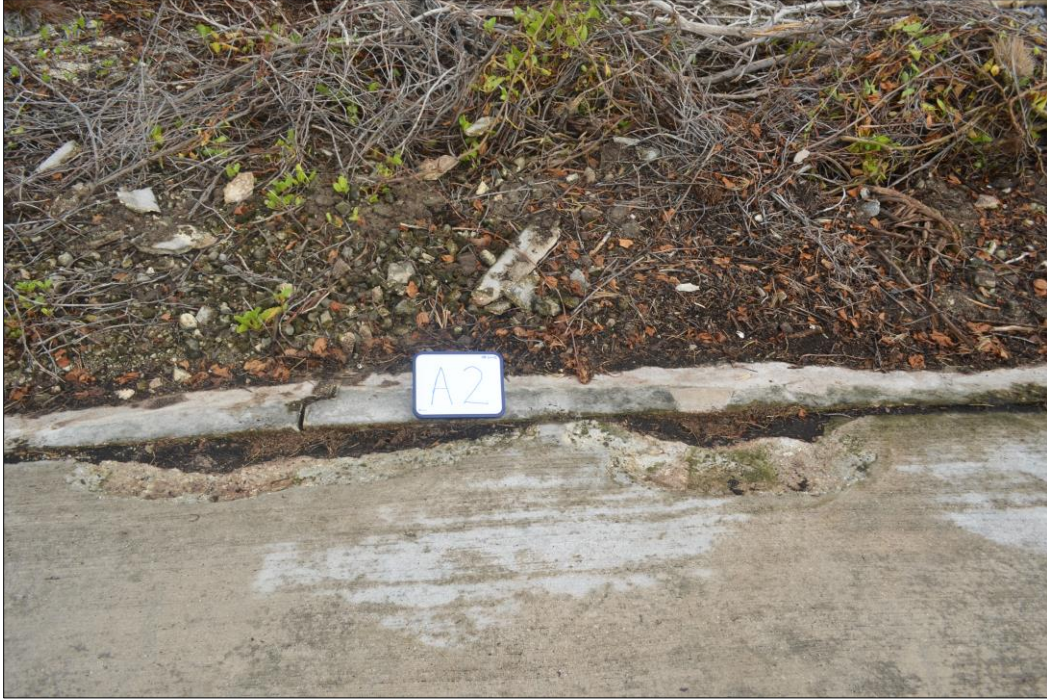
Fig. 18. Spalling of concrete along the bottom seam adjoining the keywall on panel A2.

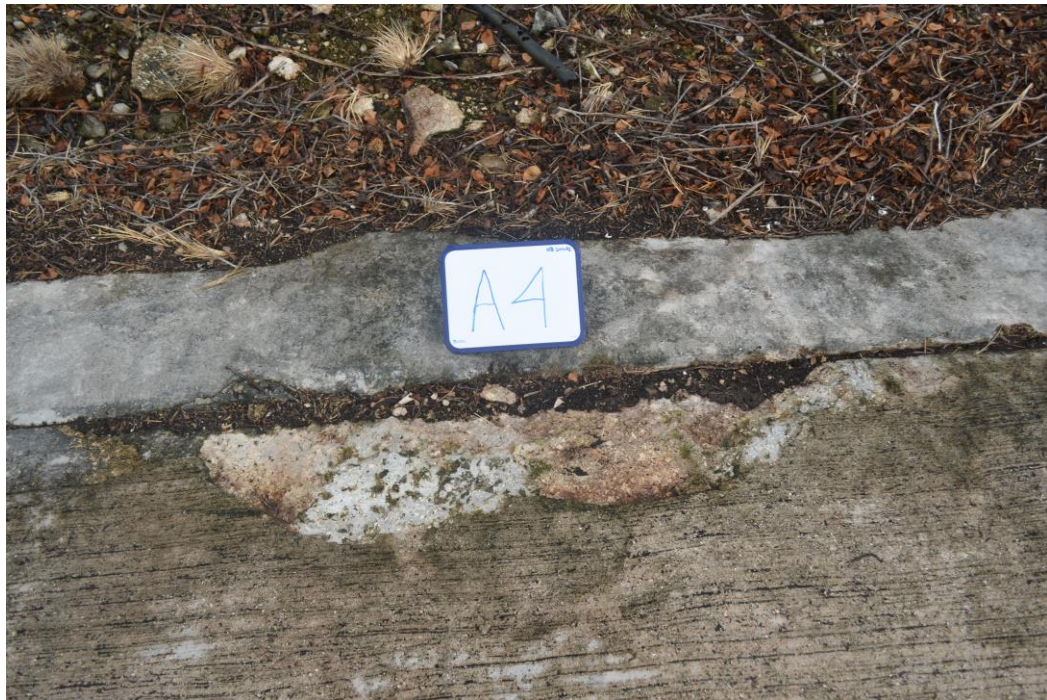
Fig. 19. Spalling of concrete along the bottom seam adjoining the keywall on panel A4.

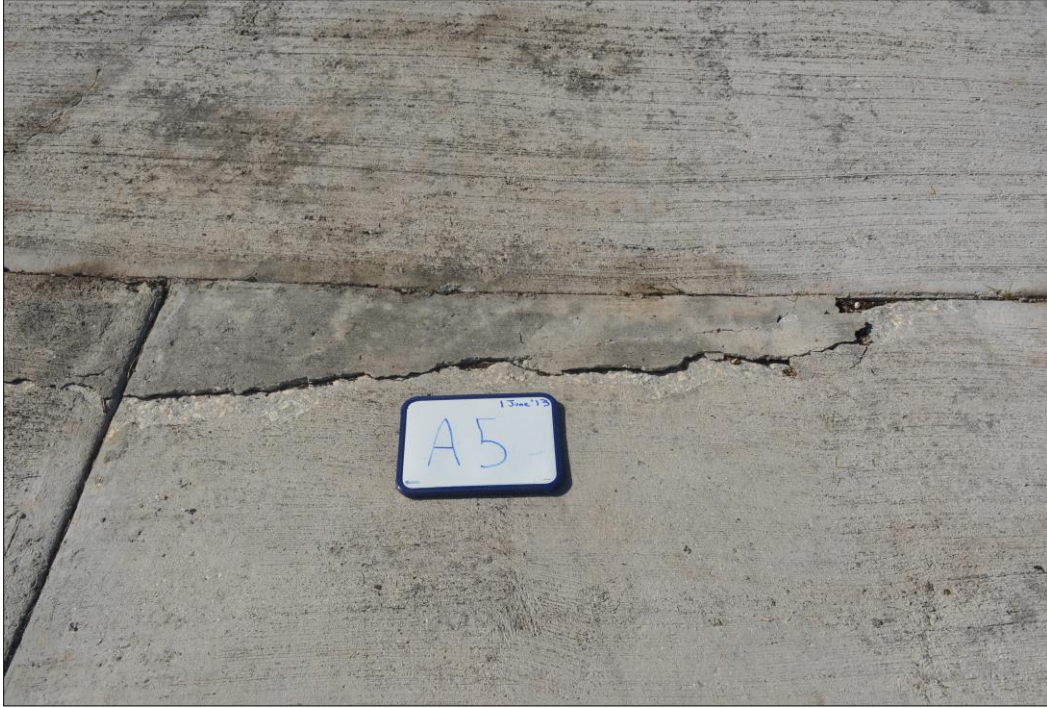
Fig. 20. Cracked concrete with spalled edges on the upper, left-hand corner of panel A5.

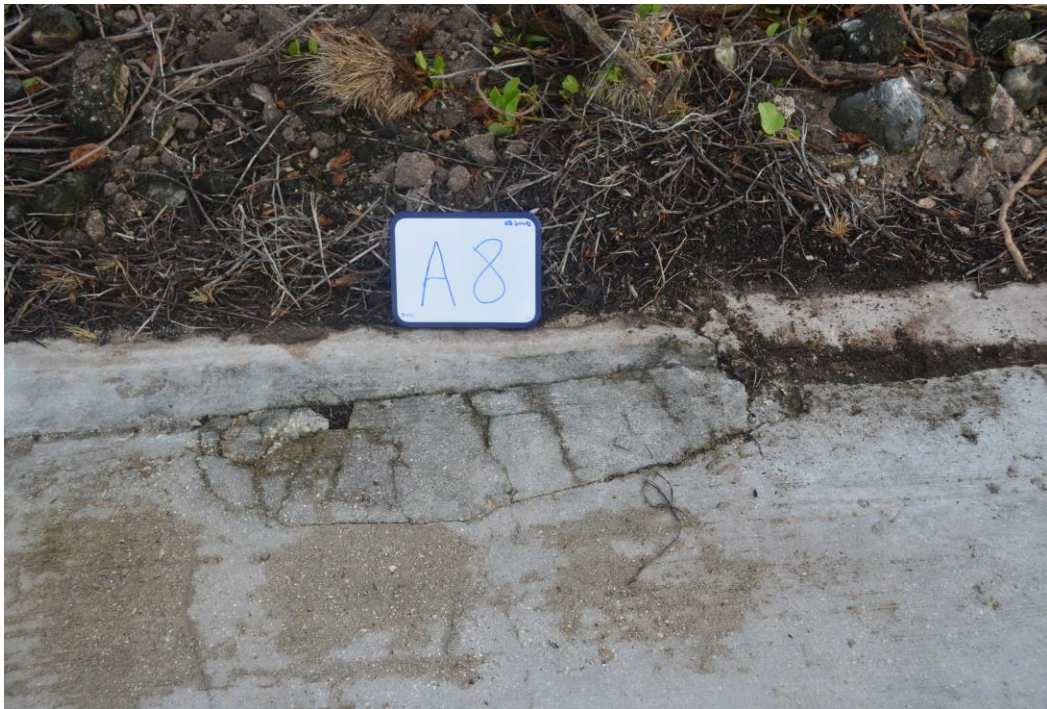
Fig. 21. Cracked concrete with minor spalling along the seam adjoining the keywall on panel A8.

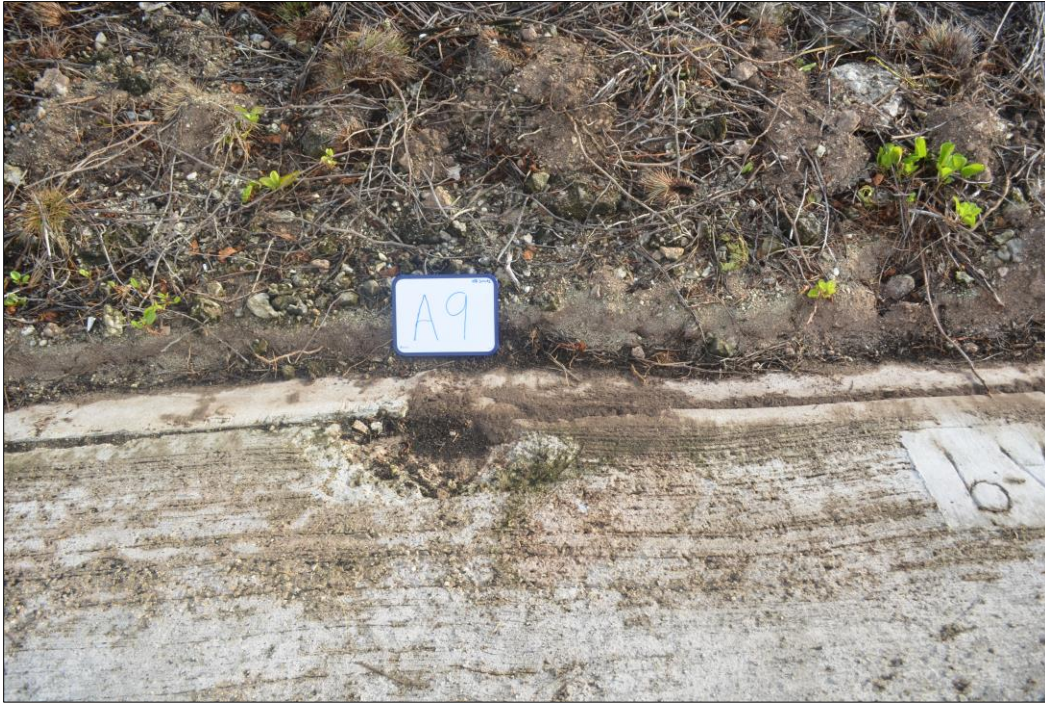
Fig. 22. Spalling of concrete along the seam adjoining the keywall on panel A9.

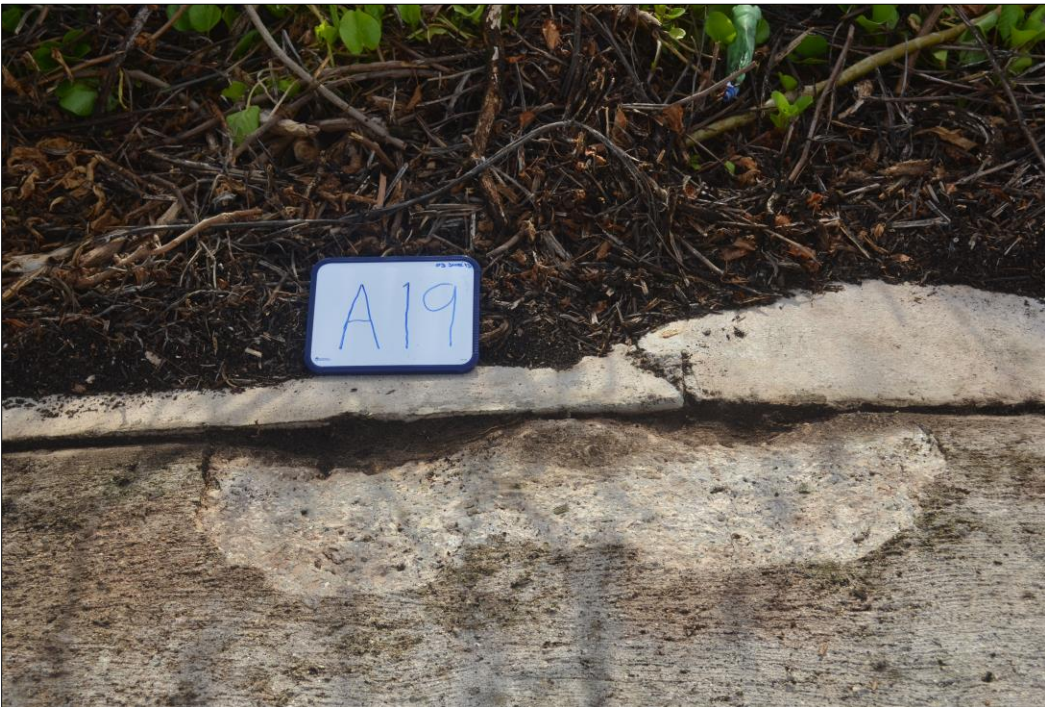
Fig. 23. Spalling of concrete along the seam adjoining the keywall on panel A19.

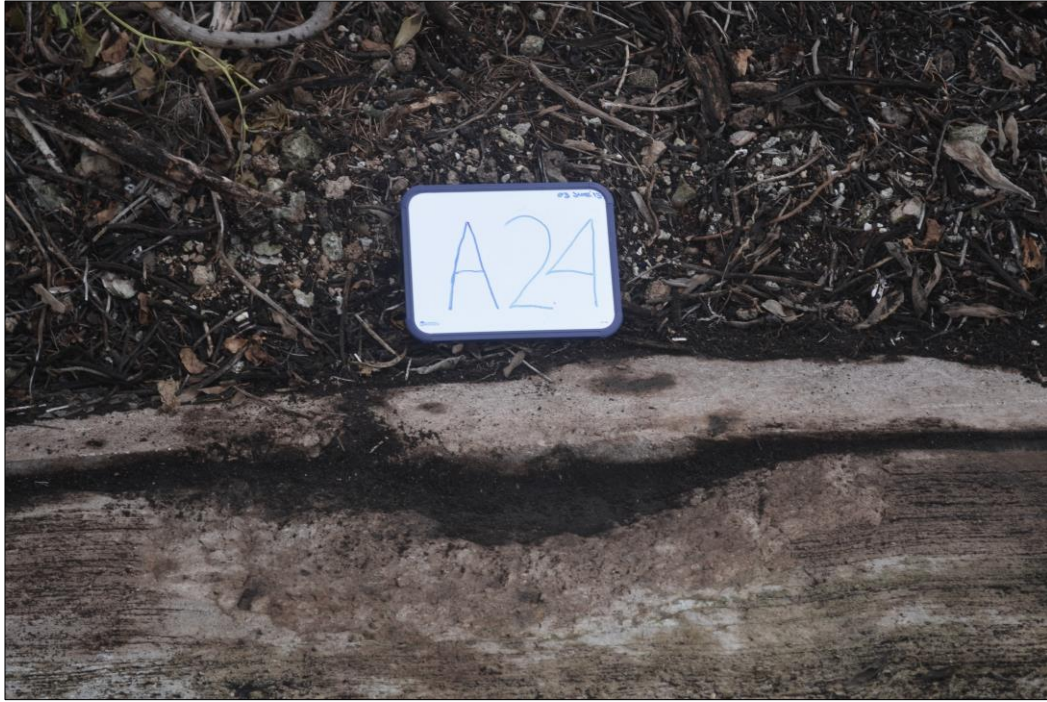
Fig. 24. Spalling of concrete along the seam adjoining the keywall on panel A24.

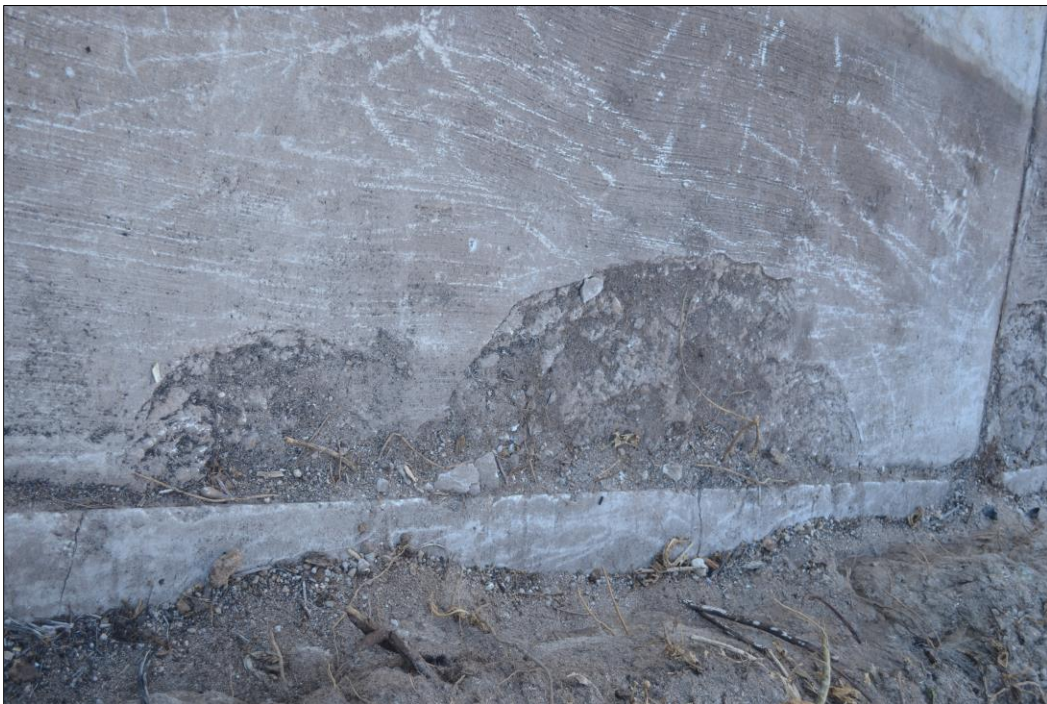
Fig. 25. Spalling of concrete in the bottom right-hand corner along the seam adjoining the keywall on panel A28.

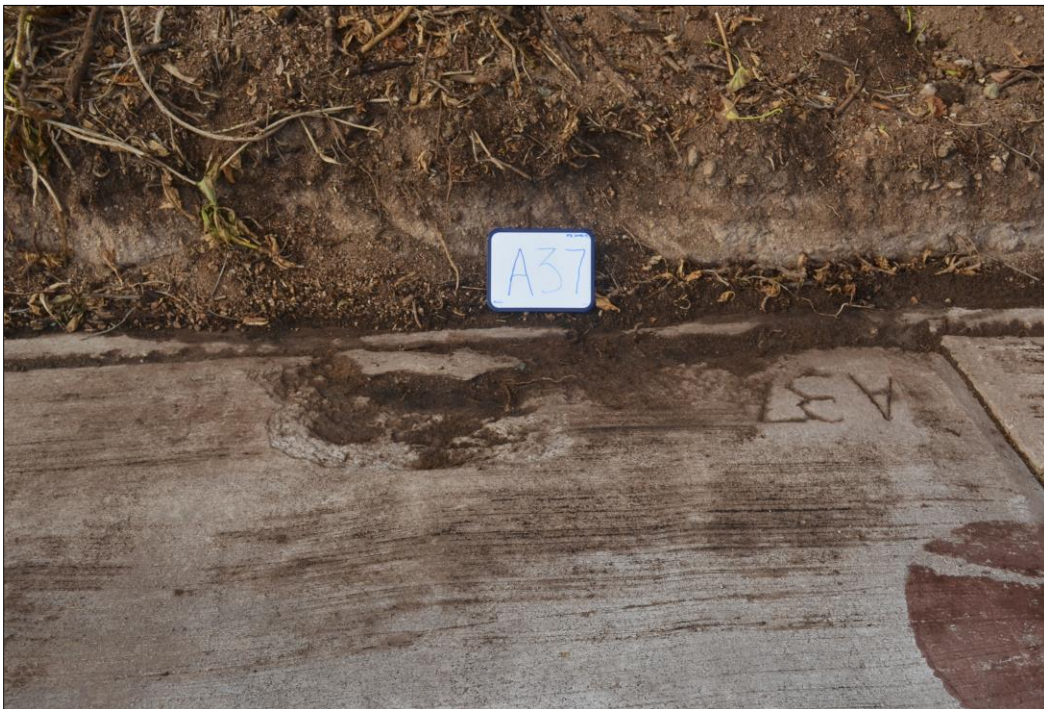
Fig. 27. Spalling of concrete along the seam adjacent to the keywall in the bottom right-hand corner of panel A37.

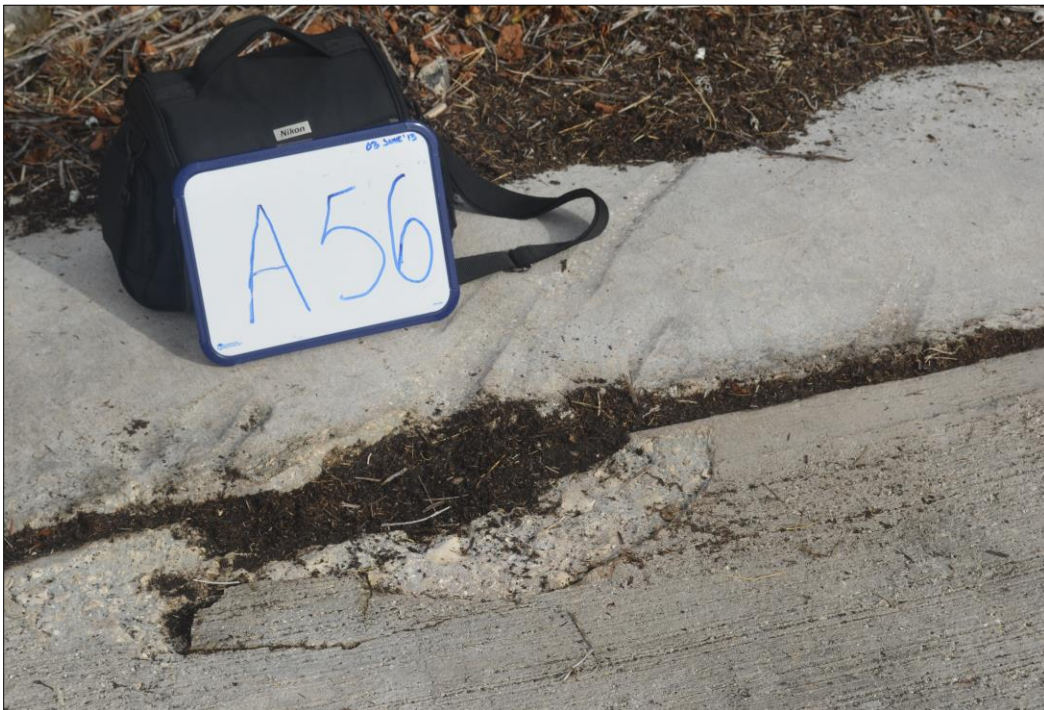
Fig. 31. Spalling of concrete along the seam adjacent to the keywall on panel A56.

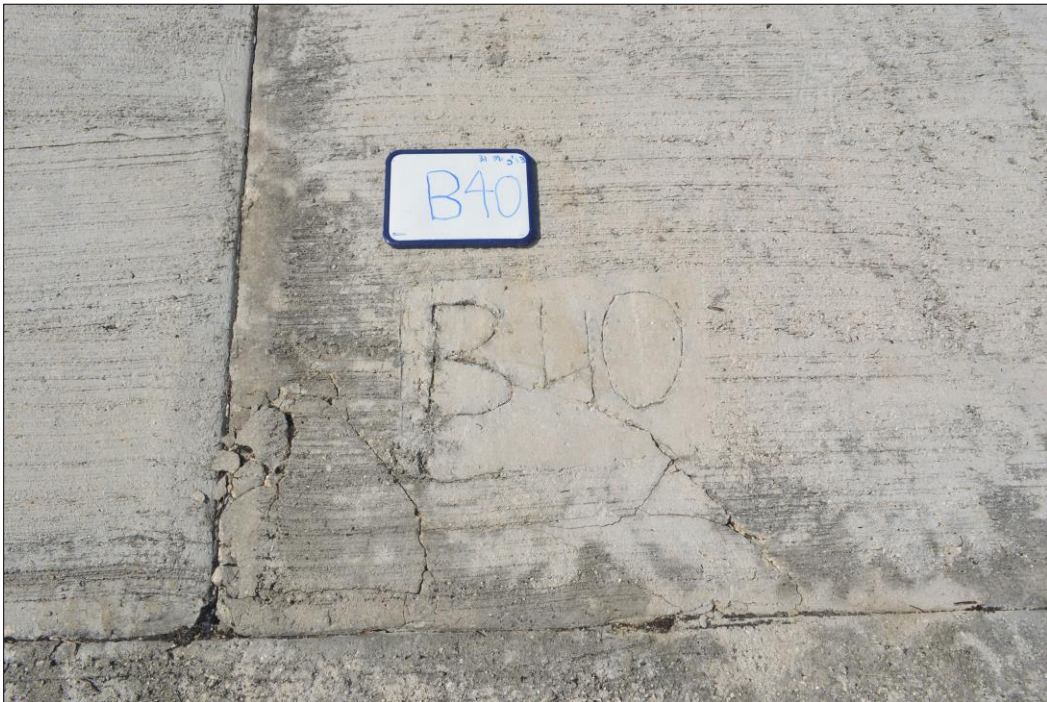
Fig. 33. Cracked concrete with spalled edges on the lower, left-hand corner of panel B40.

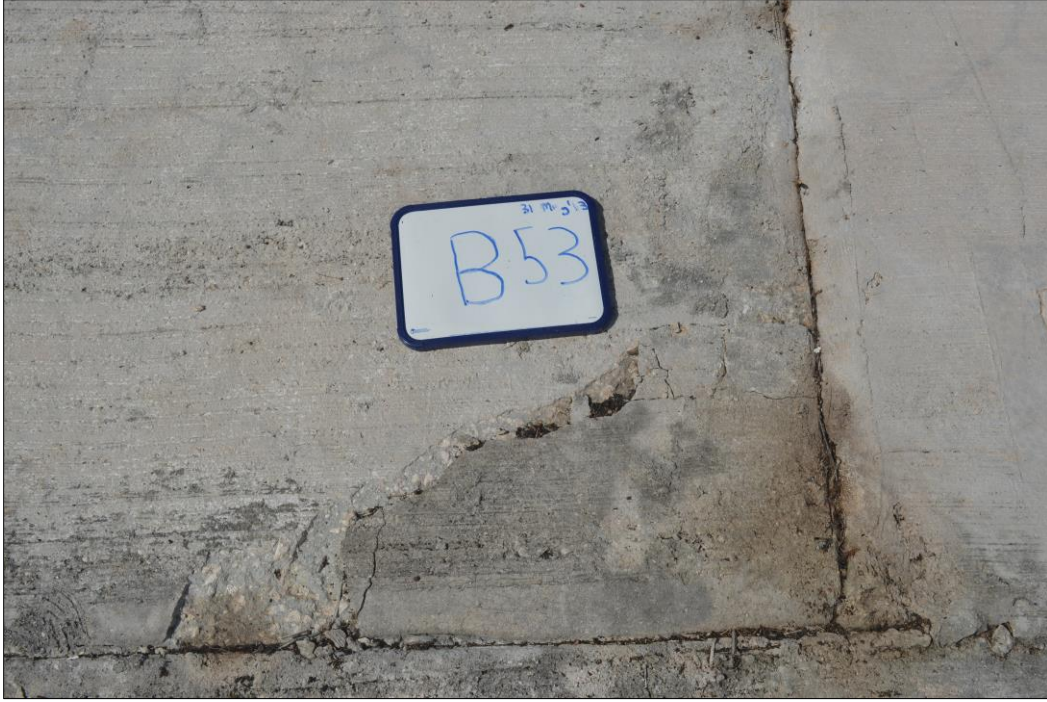
Fig. 34. Cracked concrete with spalled edges on the lower, right-hand corner of panel B53.

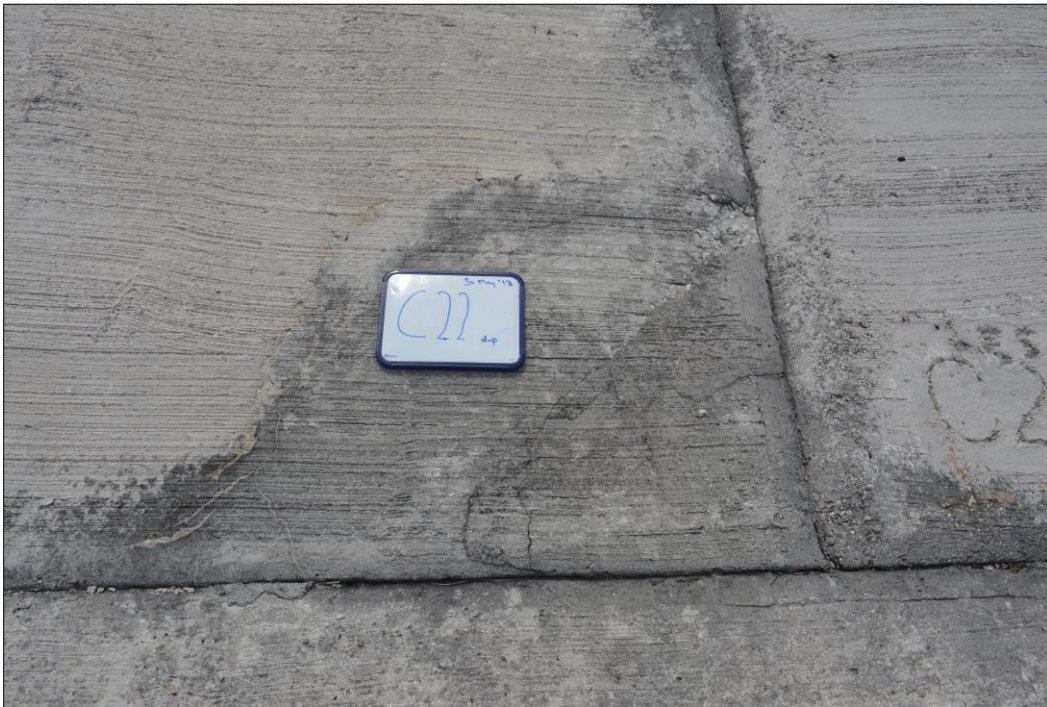
Fig. 35. Cracked concrete with spalled edges on the bottom, right-hand corner of panel C22_duplicate (position C24) [Refer Appendix I for extra panel positioning].

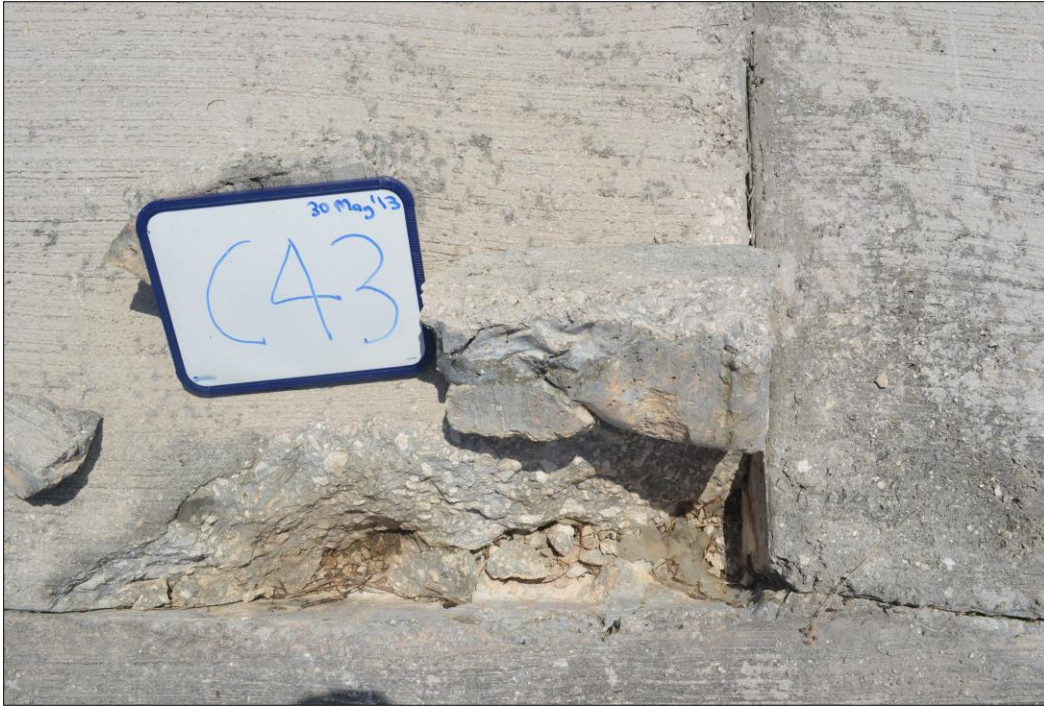
Fig. 36. Major spalling of concrete on the lower, right-hand corner of panel C43.

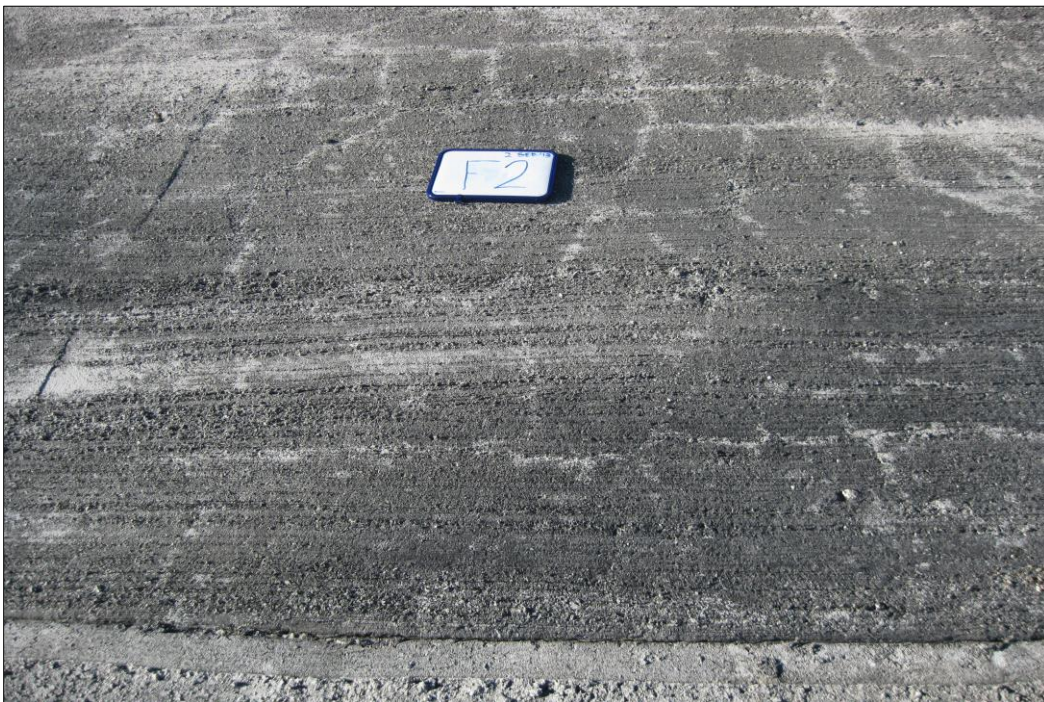
Fig. 37. A visually-defective concrete panel (F2) showing numerous minor surface cracks.

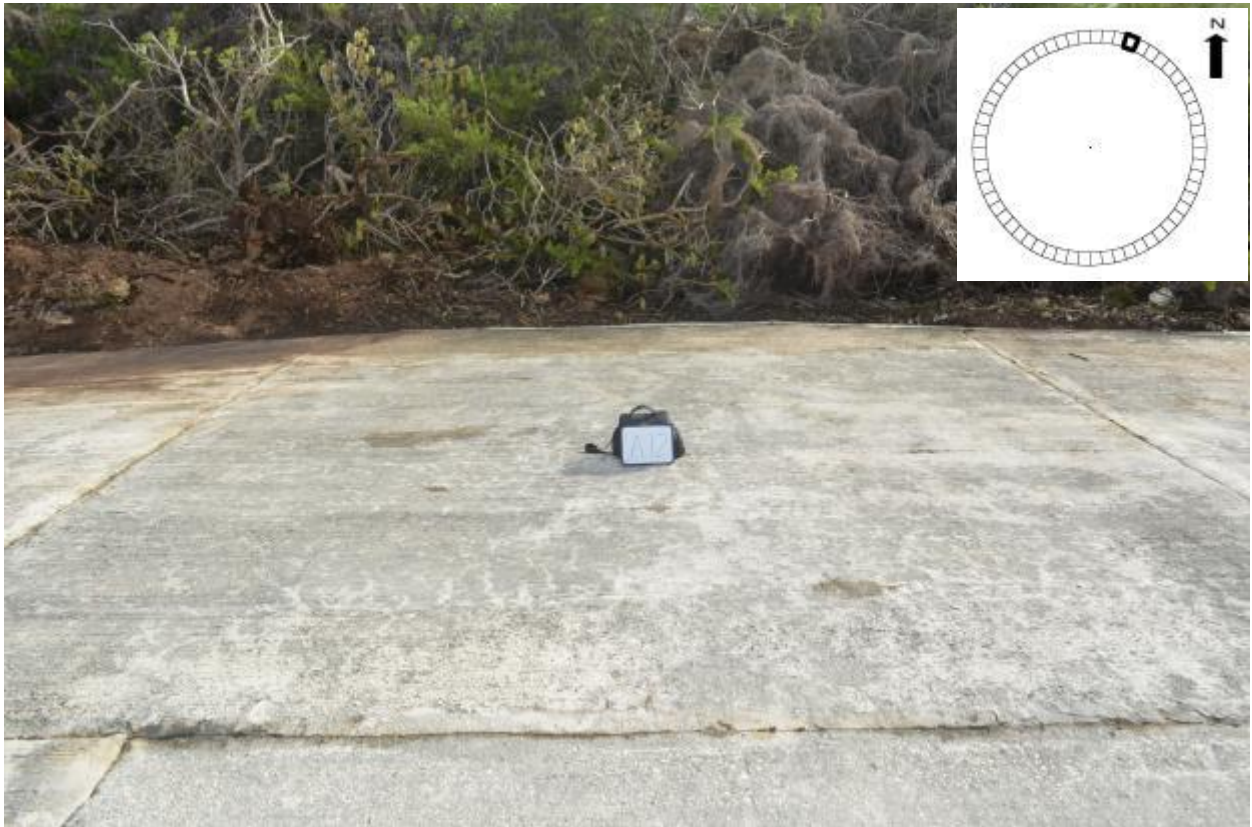
CAP SECTION LOCATION: Panel A13

No significant or obvious interior cracks extending across the top of the panel. The panel has a relatively rough weathered appearance. Some rooting vegetation removed from along the seams. Some minor spalling of concrete observed in the upper left-hand corner of the panel.

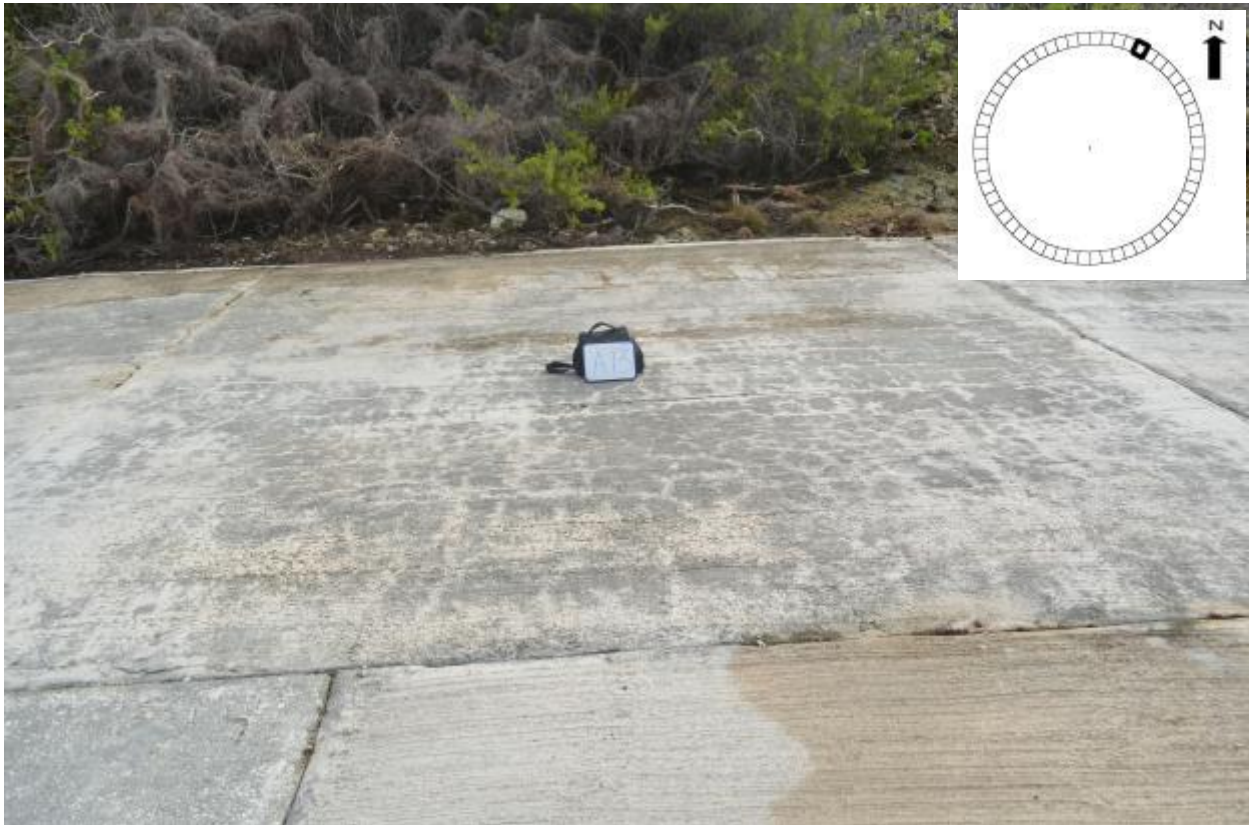
CAP SECTION LOCATION: Panel A14

The panel has a relatively rough weathered appearance. Some rooting vegetation removed from along the seams. A surface crack observed traversing across the panel from a mid-point on the left and intersecting with the right-hand seam about 3 meters up from the bottom of the panel.

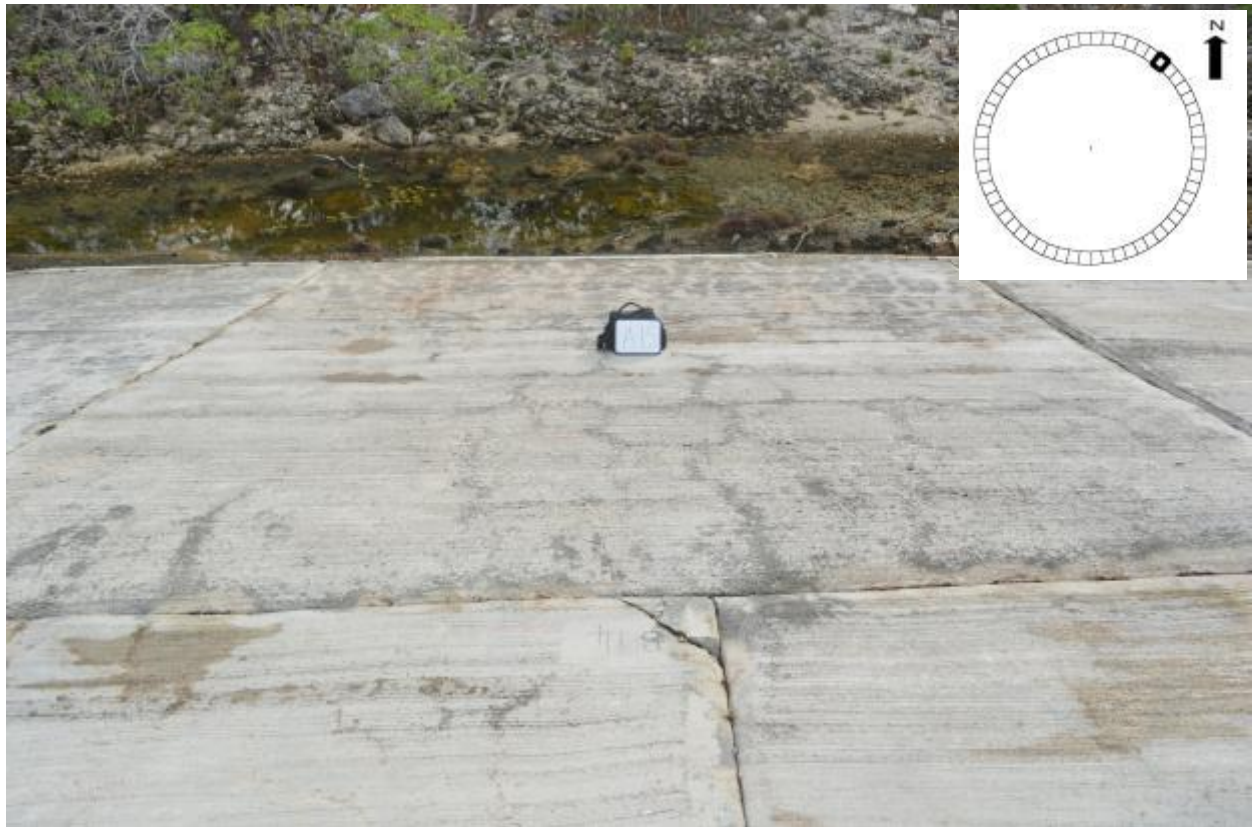
CAP SECTION LOCATION: Panel A16

Some rooting vegetation removed from along the seams. A visible crack observed traversing across the segment at a mid-point up the panel.

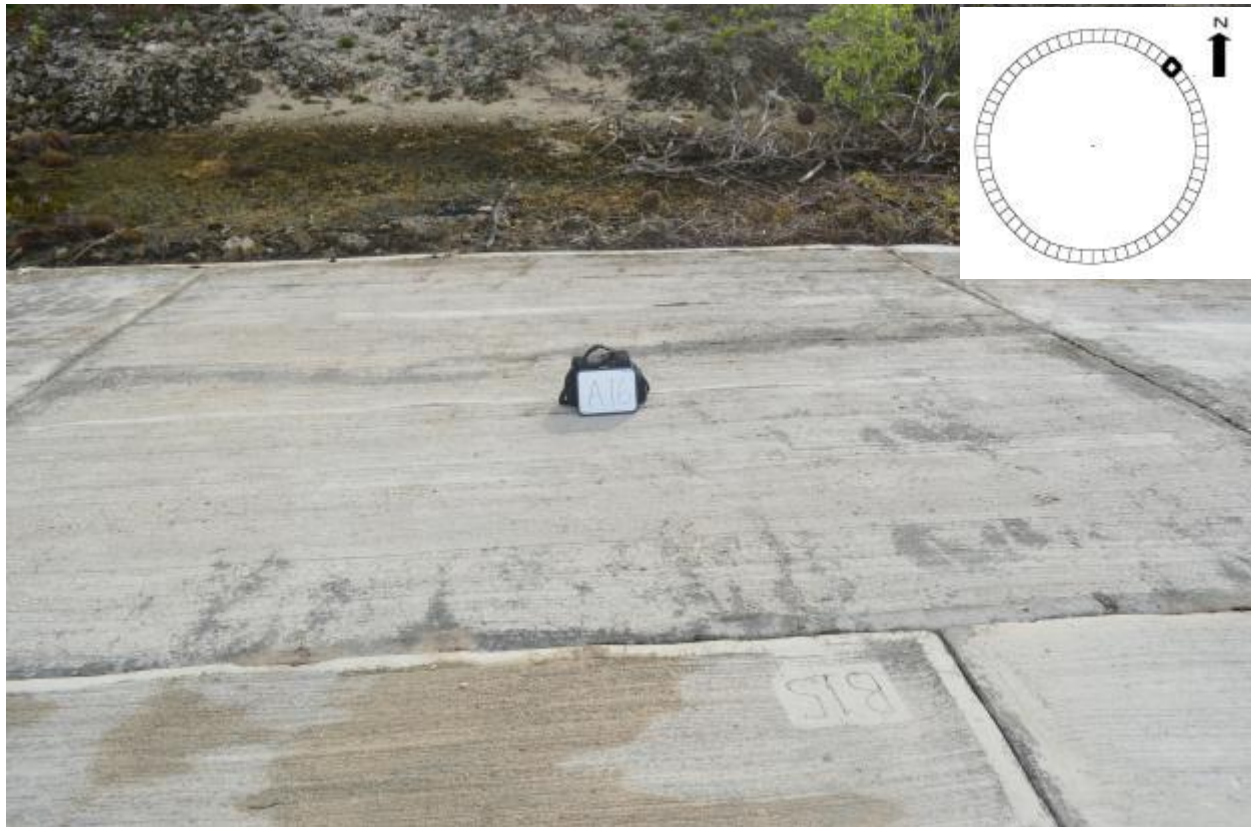
CAP SECTION LOCATION: Panel A17

No significant or obvious interior cracks extending across the top of the panel. The upper and lower sections of the panel have a relatively rough appearance. Some spalling of concrete along the keywall and adjoining bottom edge of the panel. Some cracked with chipped out edges observed along the left seam overhanging panel A18.

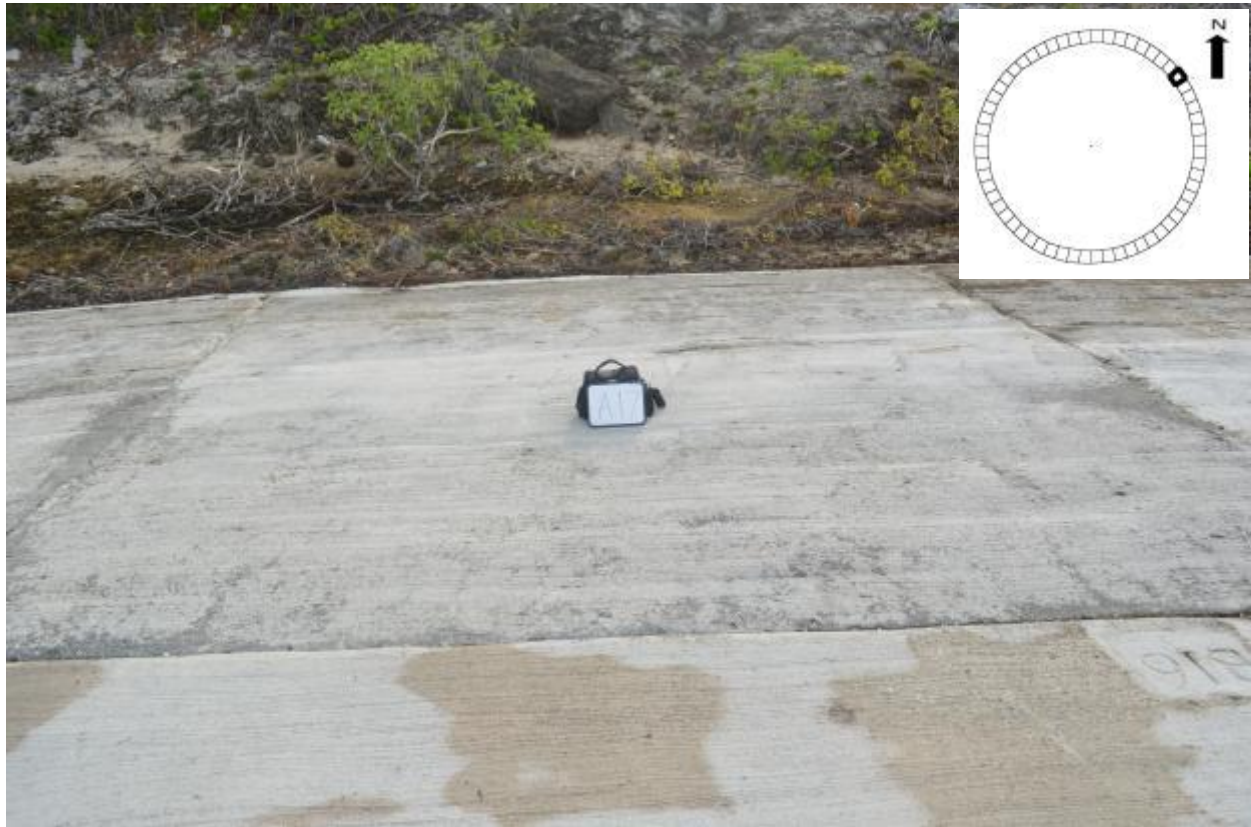
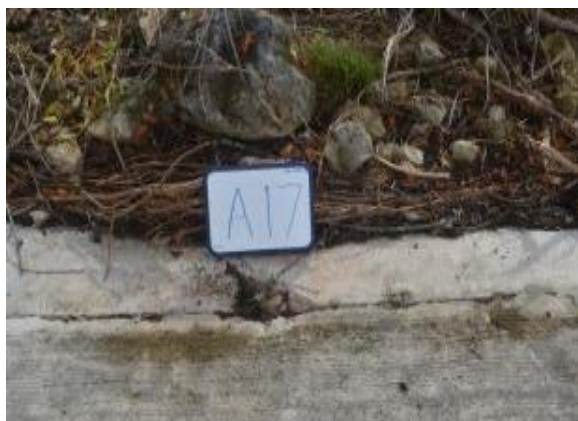
CAP SECTION LOCATION: Panel A18

No significant or obvious interior cracks extending across the top of the panel. The lower portion of the panel has a rough appearance. Some rooting vegetation removed from along the seams. There is minor spalling of concrete in the upper right-hand corner of the panel, and along the base adjoining the keywall.

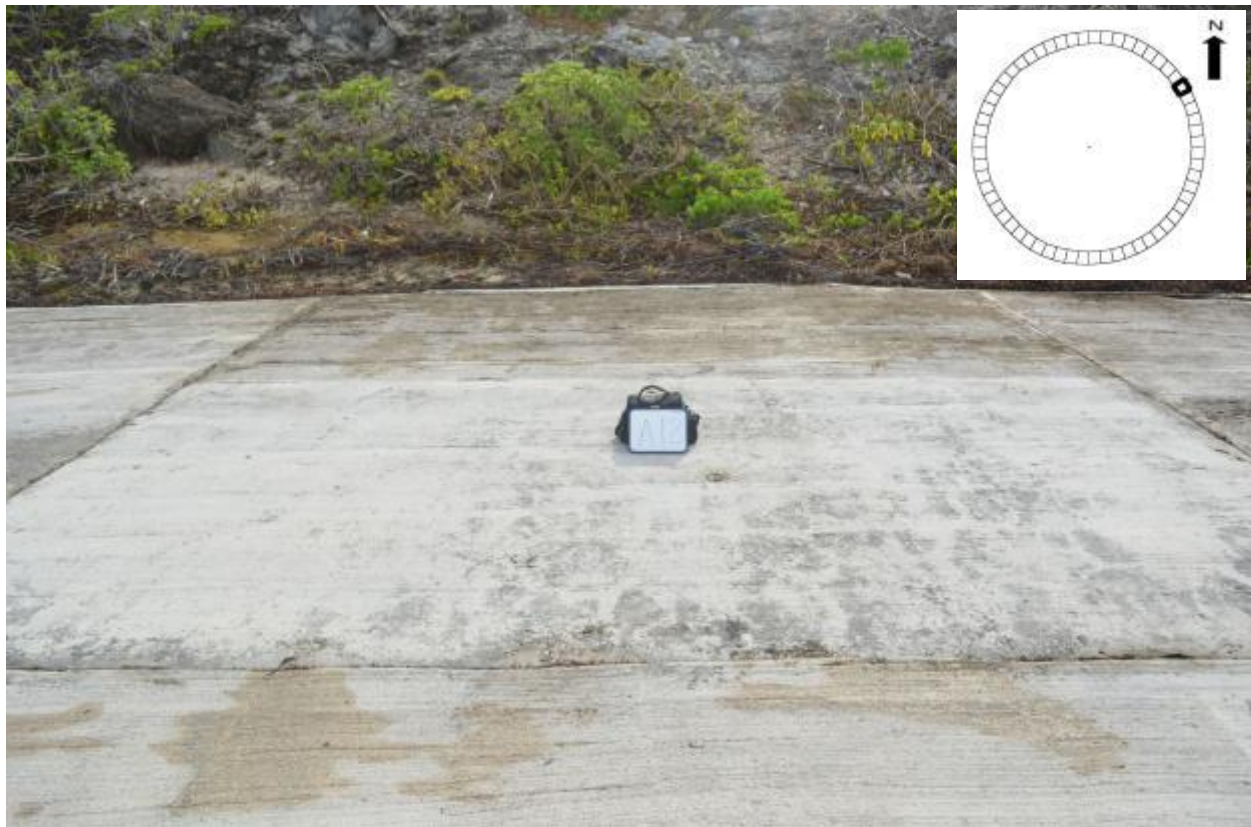
CAP SECTION LOCATION: Panel A19

The panel has a rough and weathered appearance. There is major spall of concrete along the base of the panel adjoining the keywall (app. 1.2 meters x 30-40 centimeters in area). There is also a visible crack in the concrete extending up through the middle of the panel, and minor spalls appearing along the left-hand seam.

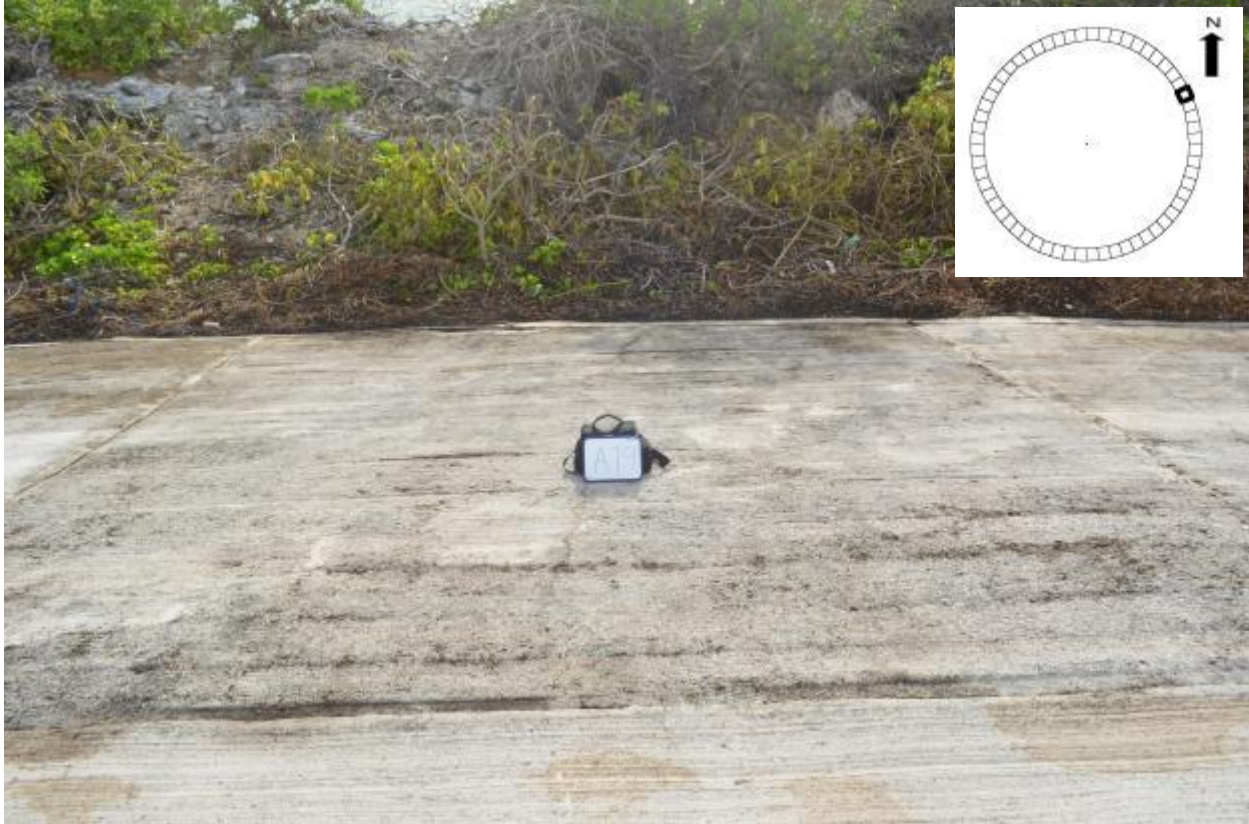
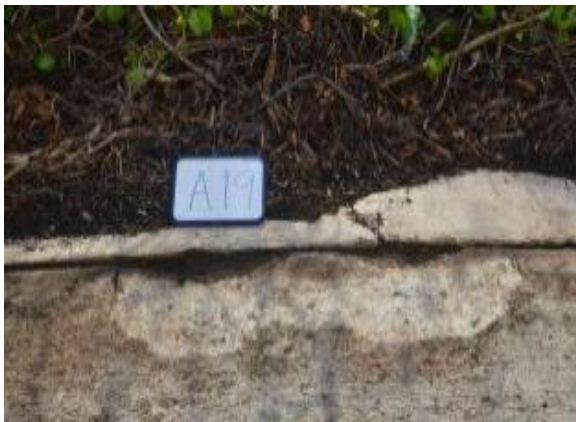
CAP SECTION LOCATION: Panel A20

Obvious spall of concrete along the bottom seam adjacent to the keywall (app. 1 to 2 centimeters deep, and 30 to 60 cm in area). Rooting vegetation removed from along the seams.
